Status of FE Electronics for ATLAS Pixels

K. Einsweiler, LBNL

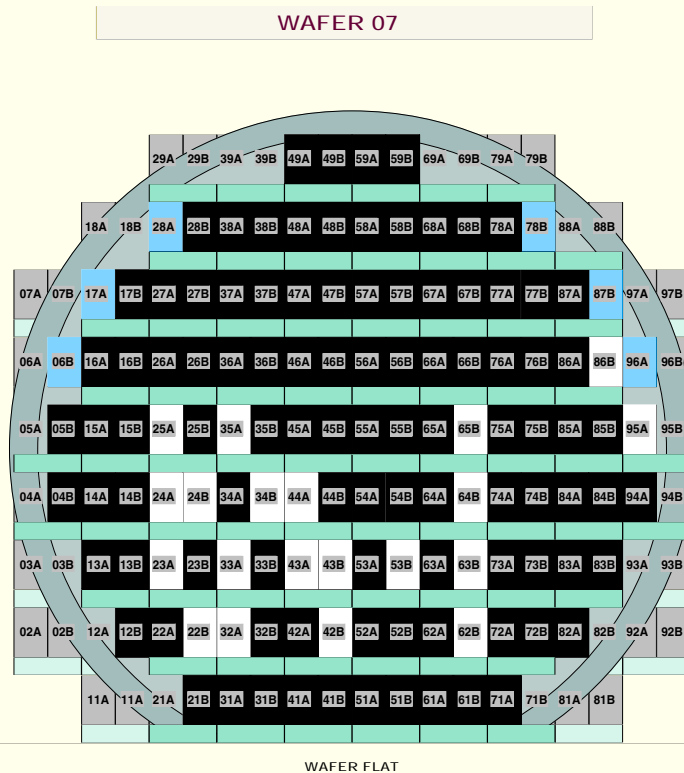
Wafer Maps

Reject dice: All blacks

- Results of wafer probe of one wafer using simple digital tests. These include correct operation of Global Register (100 bit control register at bottom of chip) and Pixel Register (2880 bit control register in matrix), and ability to correctly transmit event data.
- Three wafers probed so far, and yield for these tests is only about 25%.
- More sophisticated tests have even lower yield. In particular, no chip has anything close to zero dead channels for digital tests (previous HP chip had 92% yield for such tests).

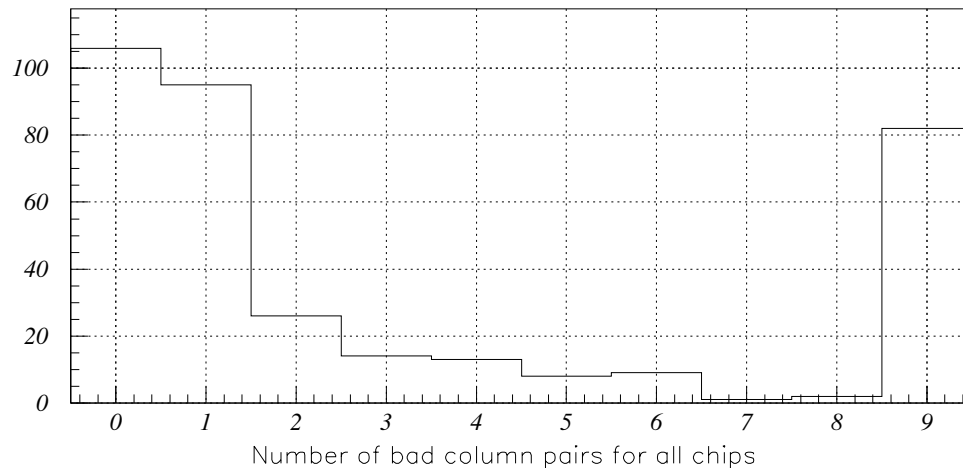
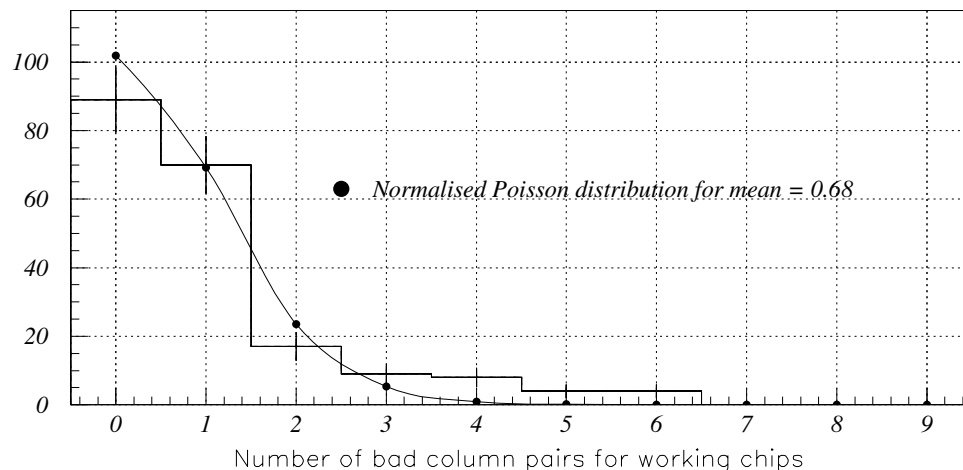
FE-D wafers 02, 03 and 07

Look at distribution of number of bad column pairs in register per die.

Find well-described by Poisson, with mean of 0.6.

This confirms notion of single-point defects, but with a very high defect density (shift register area about 4mm^2).

Suspect yield arises from high off-current in NMOS used in dynamic FF. This requires about 1 out of 1000 NMOS to fail in this way, but static logic should not be affected.

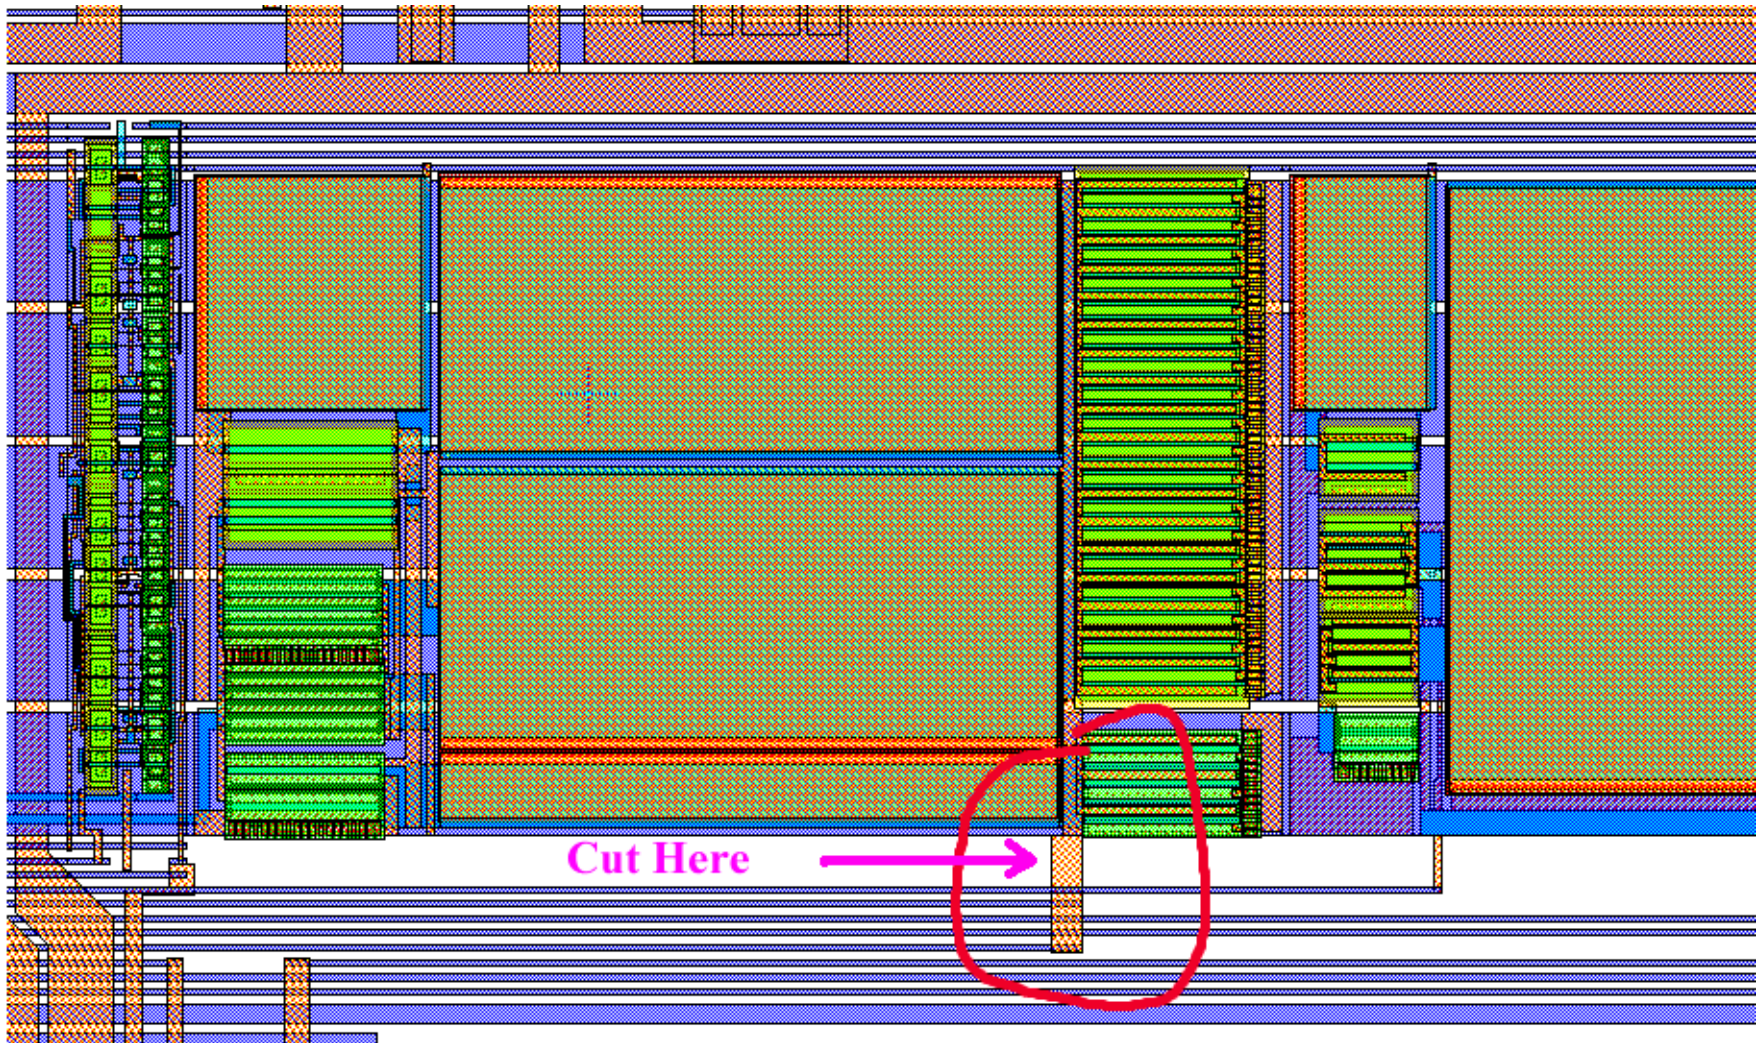
FIB Modification of Wafer #7

- First results on FE-D emerged from wafer probing, and indicated several problems. These included a layout error between two capacitors, which should have been detected by TEMIC LVS/DRC, and which killed a circuit block generating an internal threshold control voltage. This problem can be by-passed using FIB surgery.

- Decided to completely dice the lower half of wafer #7, and to perform FIB modification on 15 die with 9 good column pairs in Pixel Register test in order to allow external supply of VTH for front-ends.

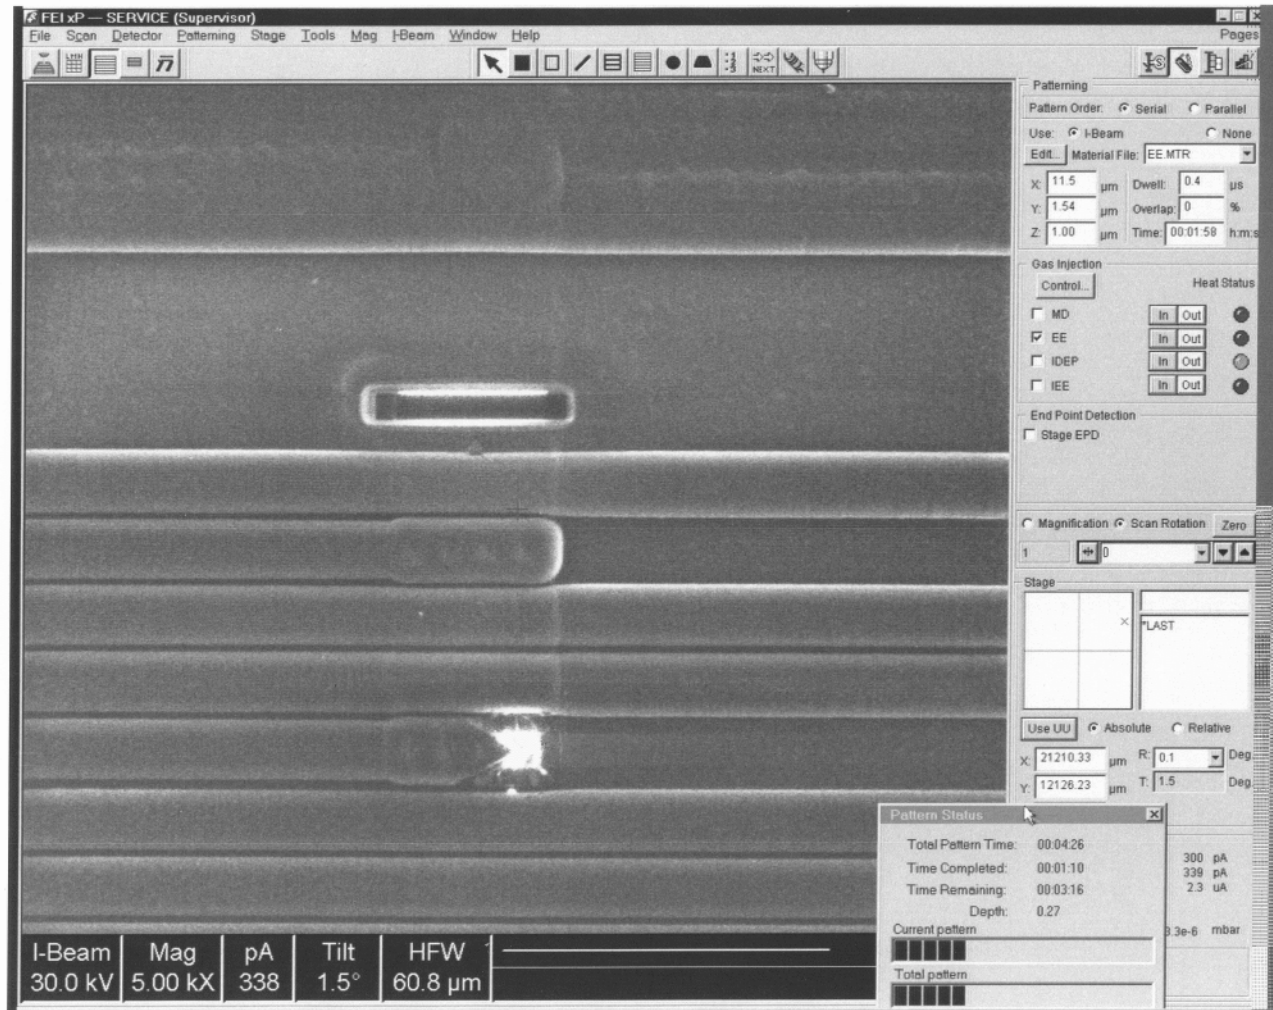
- Modification of each die took about 8 minutes on FIB machine at Accurel:

- Cut of approximately 11 μ length was made through 9 μ wide M1 trace.
- Under SEM, can see the Al remnants of the original trace as bright lines.

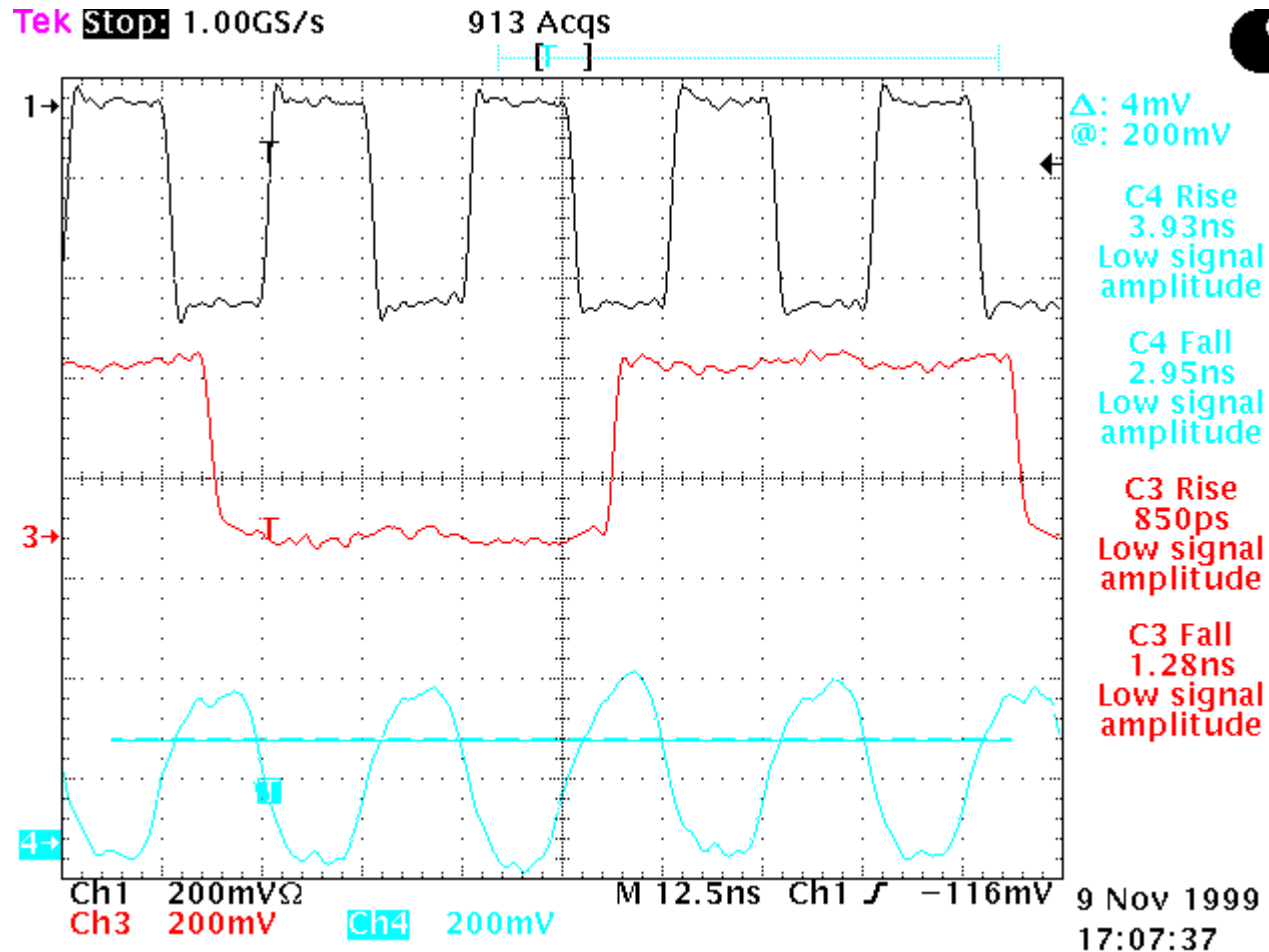
- Realized that there is a serious problem with XCK distribution inside FE-D, with relatively small transistors in LVDS receiver driving a fanout to 72 FF over a large, minimum width, set of busses.

- Observe very poor risetime on internal XCK of about 5ns (10-90%). Duty cycle at VDD/2 is still 50%.
- For reference, TSC0 is also shown. It has a risetime of about 1ns, as expected for the combined Picoprobe and scope bandwidth (500 MHz).

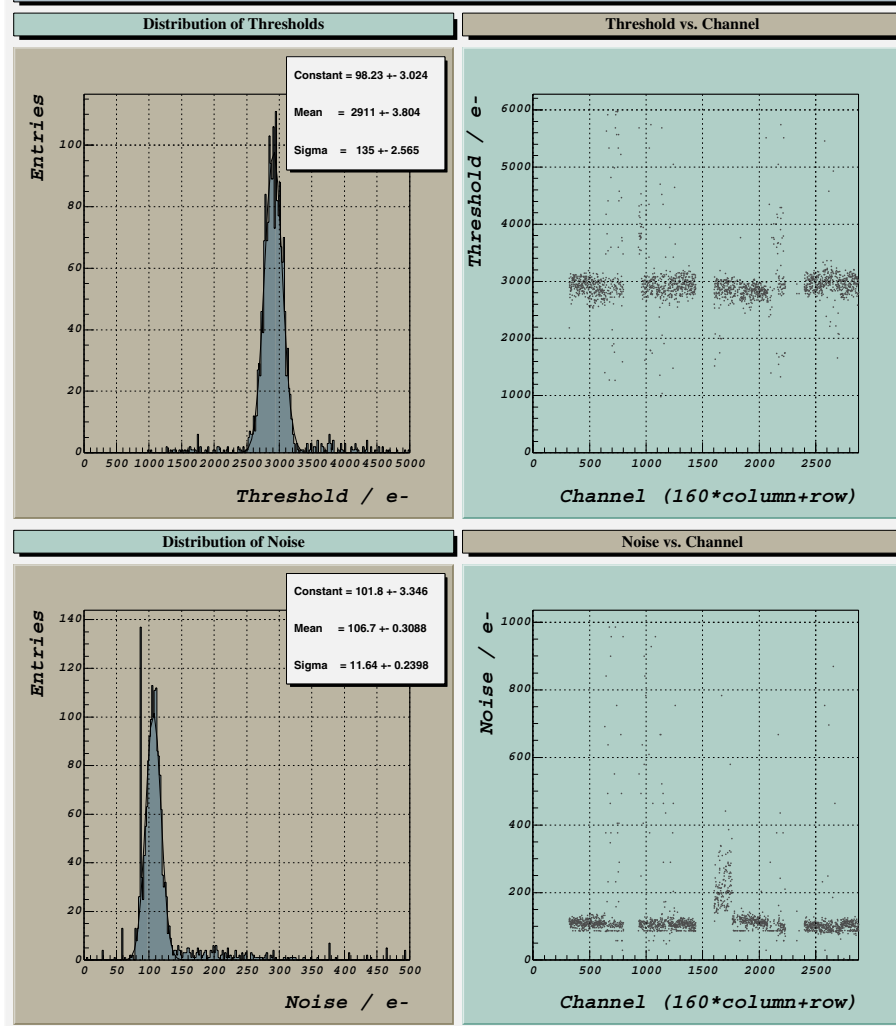
FED-1 VCCD=3600(2.2V) VTHR=3324(2.0V) IF=20 ID=IP=IL=IPS=40

- After tuning, see expected improvement in threshold dispersion:

- After tuning, the dispersion is reduced to about 135e.
- The noise is about the same, but this particular chip shows fluctuations in the noise behavior, and is often much noisier.

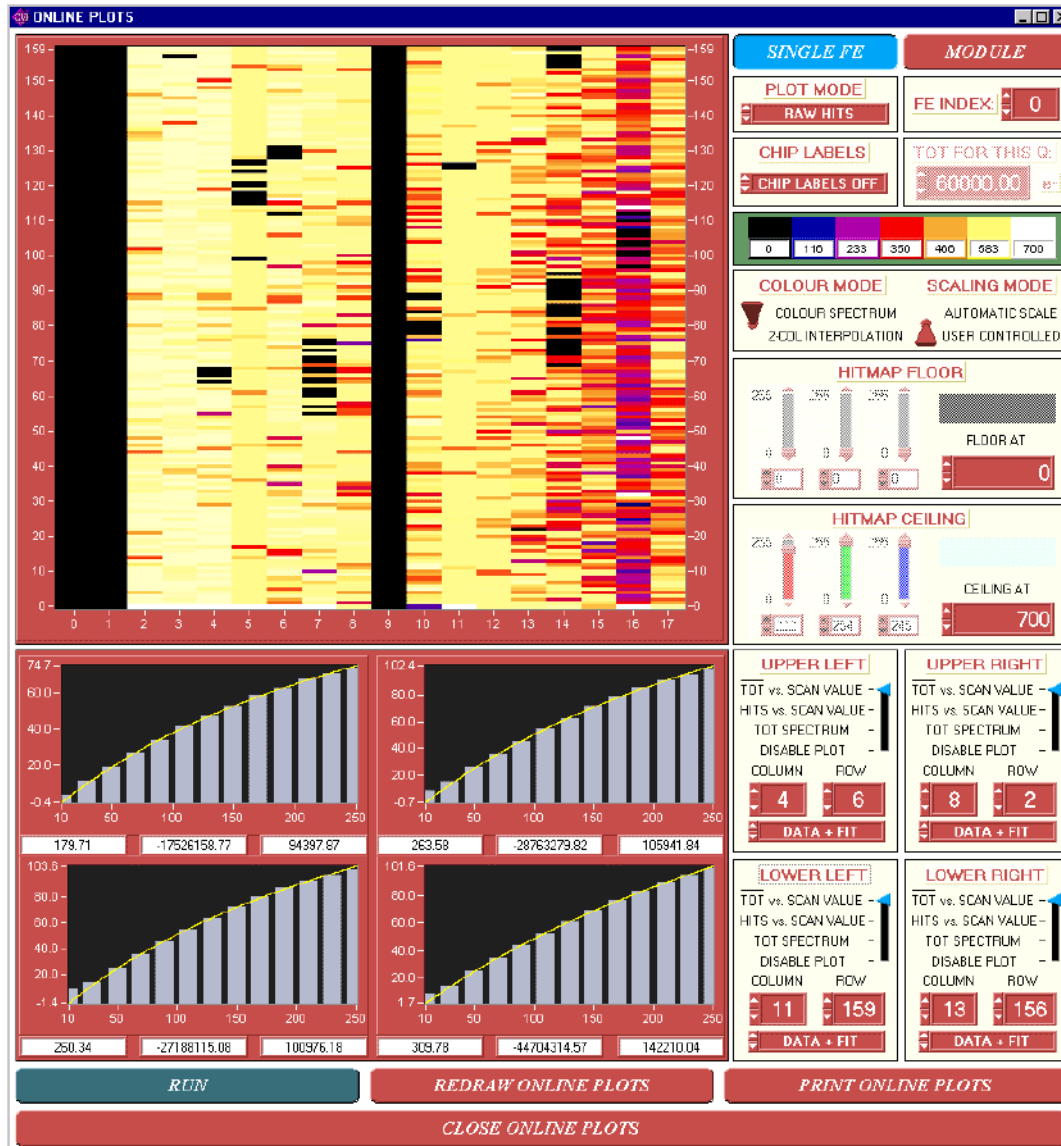
- Do a TOT scan as well to look at dispersion (required increasing IF from 20 to 35 to avoid losing hits with large charge). Used FE-D #1:

- TOT response curve is quite nice at high VCCD.
- Units are DAC counts for internal chopper DAC.

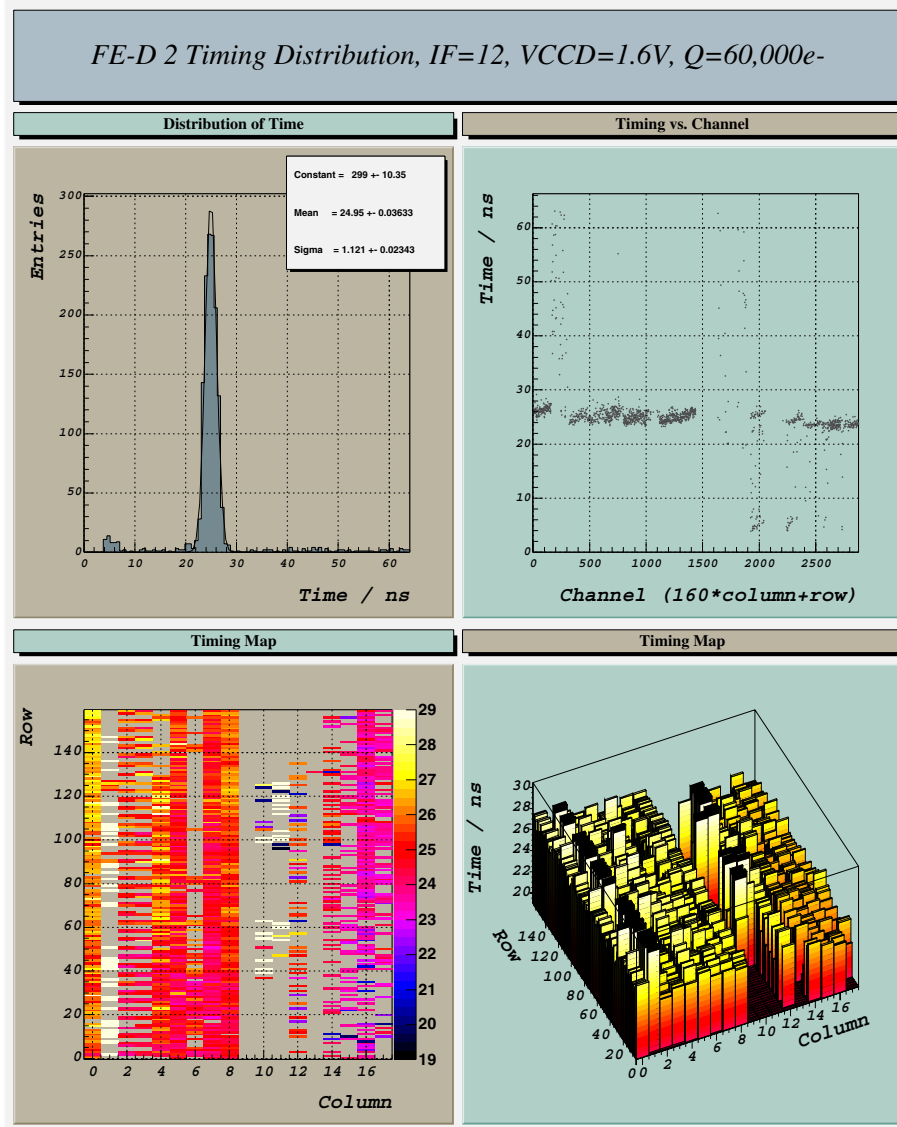
- Have also performed timing studies by injecting a large charge (60Ke) and scanning the delay to find when the hit moves from one crossing to the next:

- Scan was done for FE-D #2
- Perhaps some small indications of systematic effects, but chip had many bad/dead channels, so it is hard to tell.
- Taking an RMS over the channels gives 1.1ns, which is similar to the results obtained from FE-B in the past.
